RETOOLING CRAIG

REDEVELOPMENT OPPORTUNITY

520 & 524 YAMPA

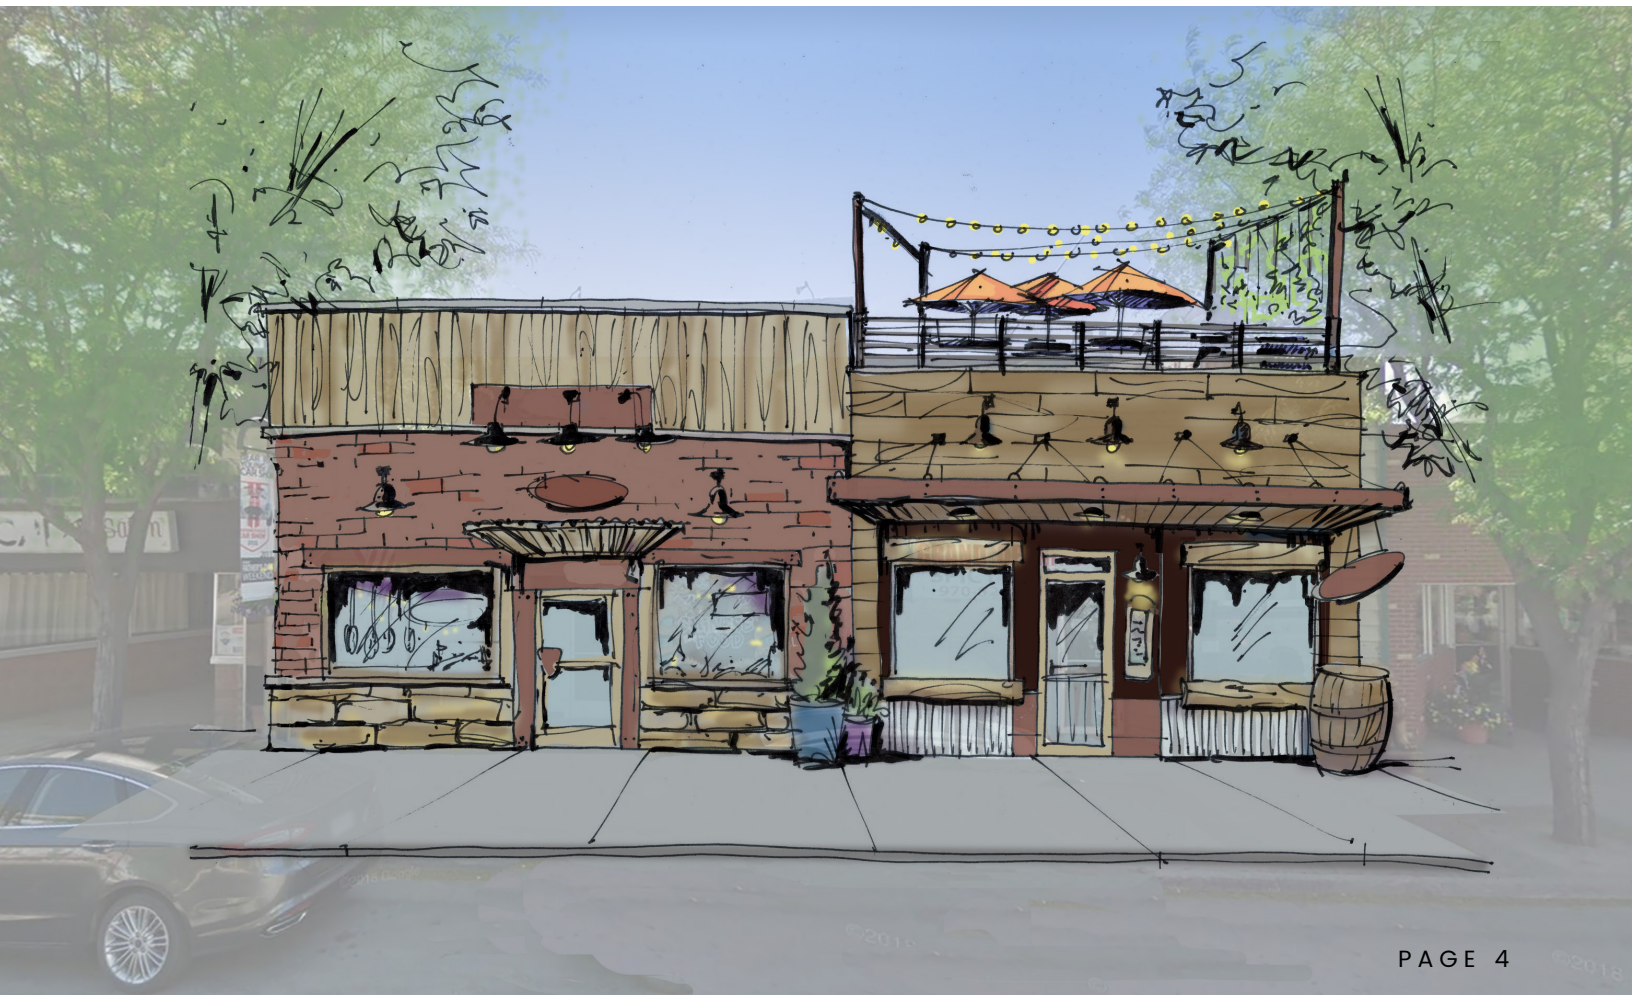
- Urban renewal demonstration. Using this new tool available in Craig is a great way to encourage more projects to get familiar with urban renewal.
- Design. The rendering below shows two distinct facades and utilizes architectural details such as awnings, lighting, and various building materials to add visual interest and promote human scale design. The goal will be to design the facades in a way that contributes to a safe, active, and vibrant street life. In 2014, the City developed Façade Improvement Guidelines for Yampa Avenue. This document is available upon request and should be used to guide design decisions during the redevelopment process.
